# MONUMENT RECORD

Q-13

STATE OF INDIANA - COUNTY OF MONROE

Section Fourteen (14), Township 10 North, Range 1 West

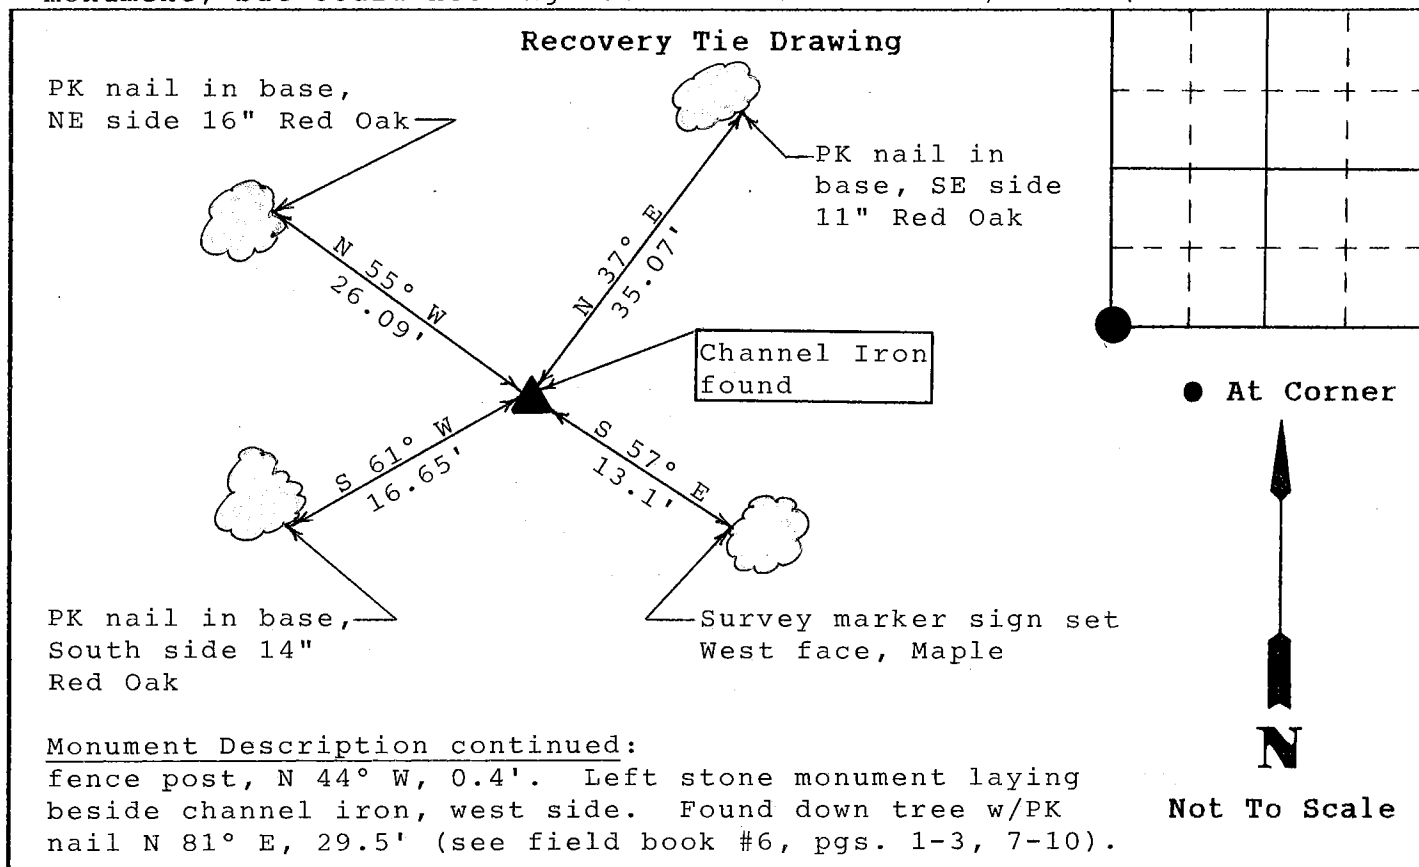
Monument Description & Remarks: Found Channel Iron at SW corner of section,  
0.14' x 0.12' x 1.0' out of ground. Attempted to replace iron w/stone  
monument, but could not dig out. Marked corner w/steel (continued below)

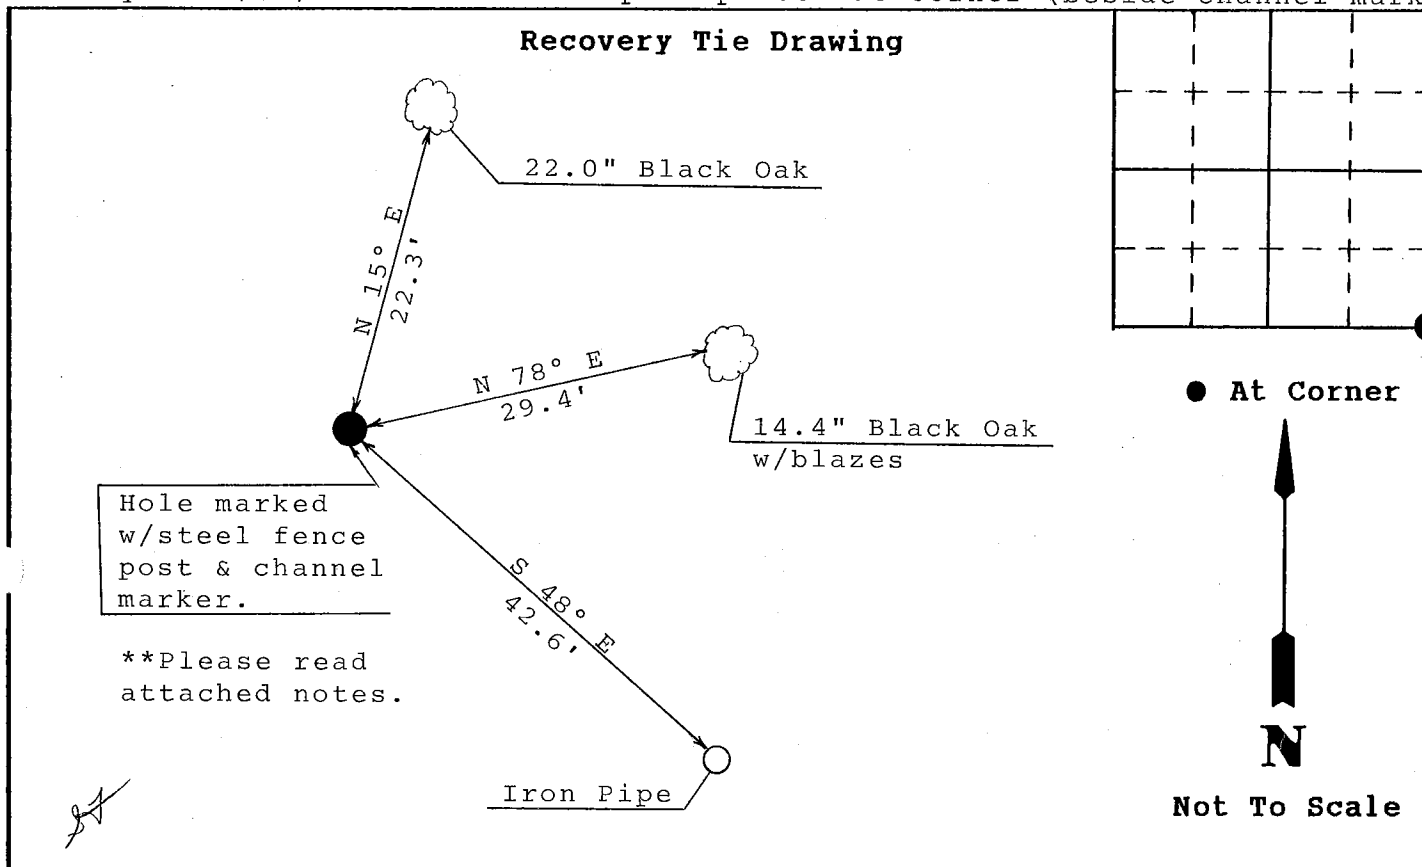
**Monument Description & Remarks:** Based on evidence, hole at SE Corner accepted  
as section corner 10/18/85. Location of corner substantiated by County  
Surveyor? 7/29/88--Steel fence post placed at corner (beside channel marker)
